ERGO M (AM72/80/384) RECLINE STOP ANGLE FIELD INSTRUCTIONS

Assembly Instructions

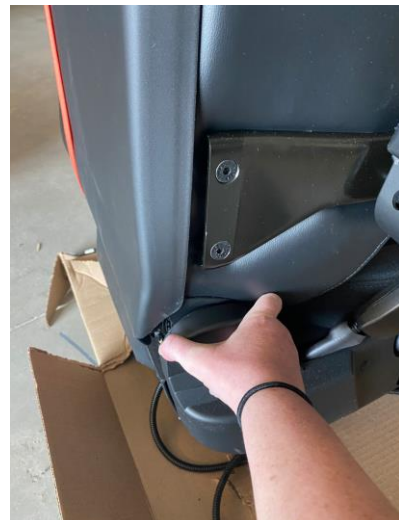
FIGURE 1

STEP 1: Rotate the seat back forward to just forward of 90 degrees to allow access to the rear of the seat and to ensure the recline stop can be removed (figure 1).

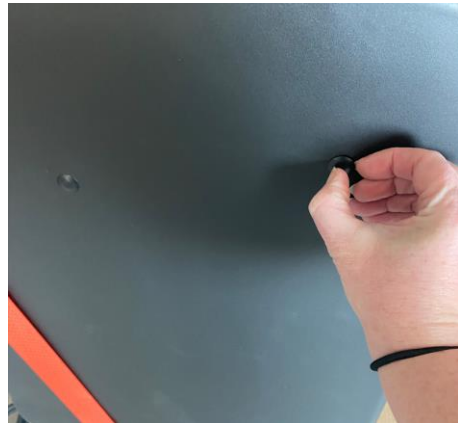
FIGURE 2

STEP 2: Using a small flat head screwdriver or pick, remove the 2 caps on the back of the plastic back protector for AM384 or 3 or 4 caps for AM72/80 to gain access to the attachment screws. Set caps aside. (figure 2).

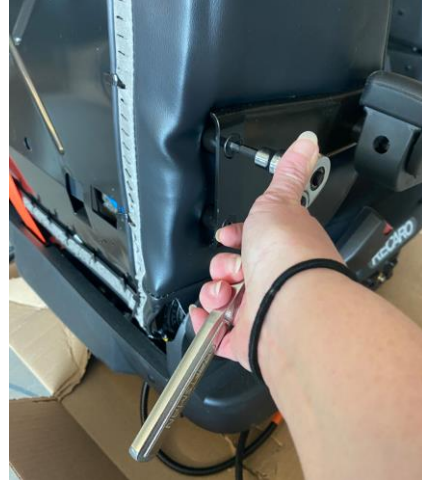
FIGURE 4

STEP 4: If the seat is equipped with a right-hand armrest, remove the bolts securing the armrest to the seat using an M5 hex drive wrench. These bolts also secure the recline stop bracket to the seat. If the seat does not have an armrest, skip to the next step (figure 4).

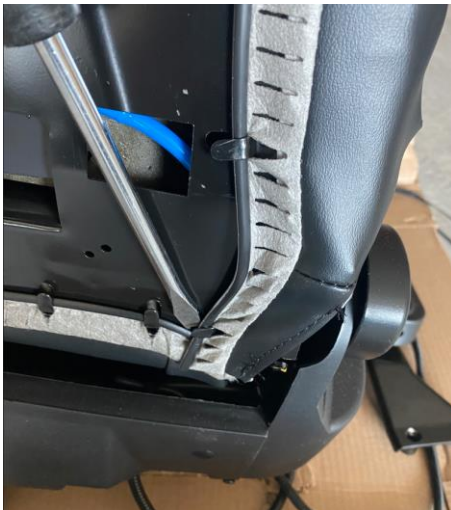
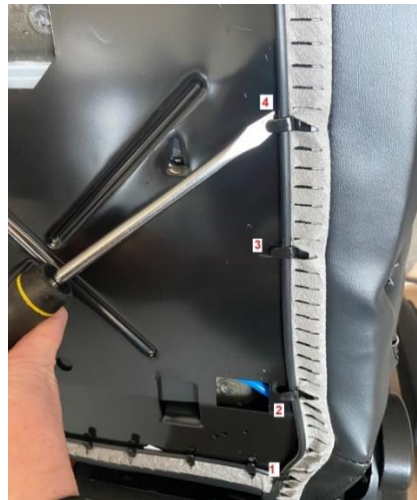
FIGURE 5

STEP 5: Using a large flat head screwdriver, pry up the tabs on the back frame that hold the retainer on the trim cover in place. Using the end of screwdriver, push the trim cover retainer off the tabs (figure 5).

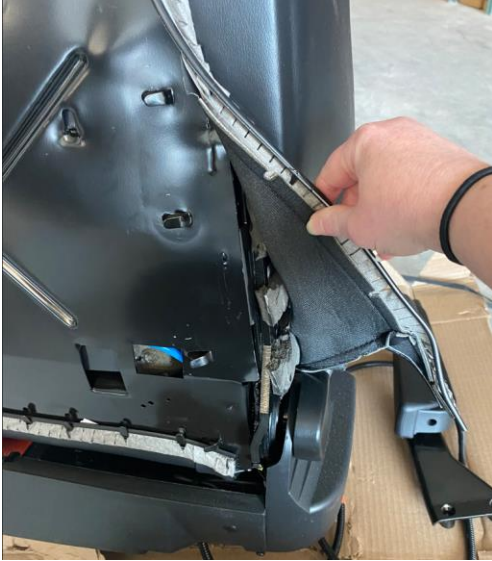
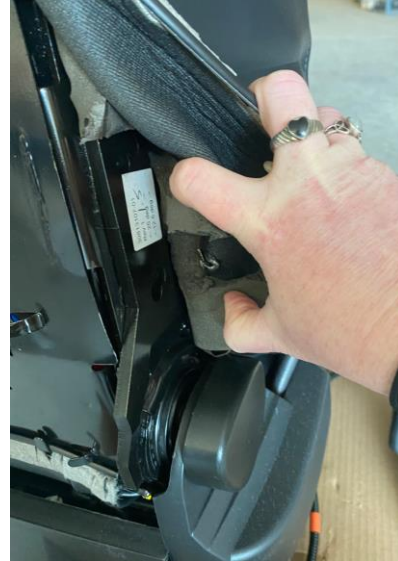
FIGURE 6

STEP 6: Gently pry the trim cover and foam away to gain access to the recline stop bracket. If there were armrests on the seat, the bolts would have already been removed. If the seat does not have armrests, remove the attachments bolts using an M5 hex drive wrench (figure 6).

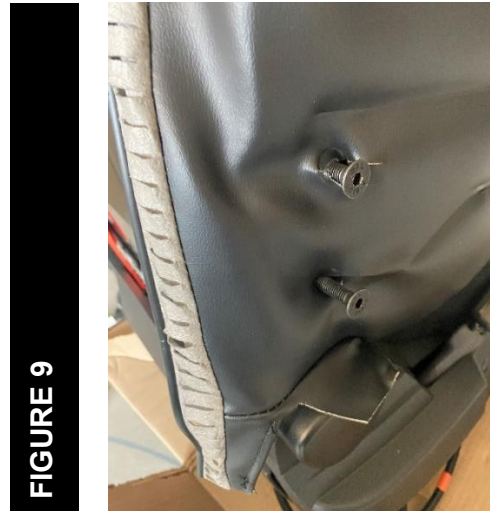
STEP 10: Wrap the trim cover back over the recline stop bracket. If the seat came with armrests installed, push the head of the bolt through the hole in the trim cover (figure 9).

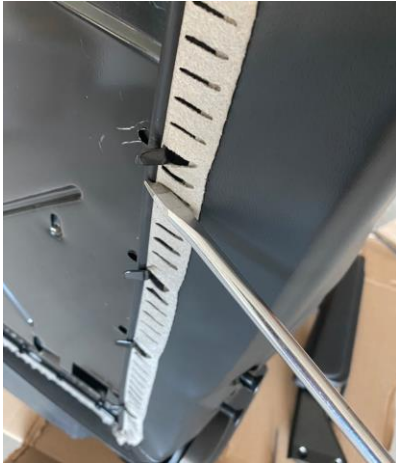
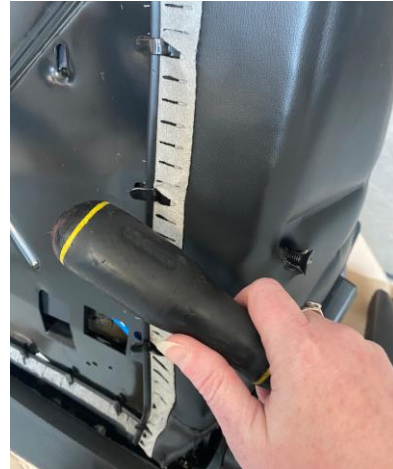
FIGURE 10

STEP 11: Reinsert the trim cover retainer on the tabs on the back frame by using the end of the flat head screwdriver to push the retainer over the tab. Push all the tabs flat to the back frame, either with the end of the screwdriver or with a rubber mallet (figure 10).

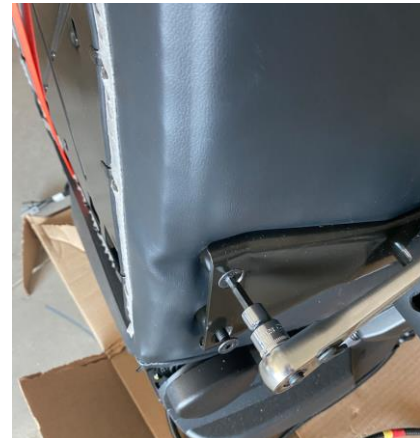
FIGURE 11

STEP 12: If the seat came with armrests installed, remove the hand tightened top bolt from the recline stop bracket and position the armrest. Once the upper bolt is hand tightened again, remove the lower bolt, secure the armrest in place and re-hand tighten. Torque bolts to 22 Nm. (By removing one at a time, you ensure that the recline stop bolt does not shift under the trim cover.) (figure 11).

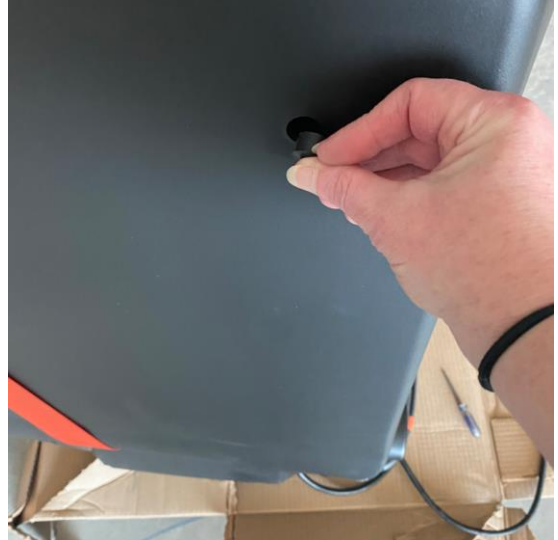
FIGURE 12

STEP 13: Reposition the plastic back protector onto the seat back by placing the 2 lower hooks into the frame and aligning the upper holes for the screws. For an AM384: Ensure that the seat belt webbing is placed outside of the panel and is pinched between the plastic and metal. For an AM80: Ensure that the seat belt webbing is placed between the plastic and metal. Once the screws are tightened, replace the caps (figure 12).
